## **OEL Disassembly Drawing**

## C9200/C9400

Revision 6

# 1. Printer Unit Parts Layout Main Assembly(1/3)

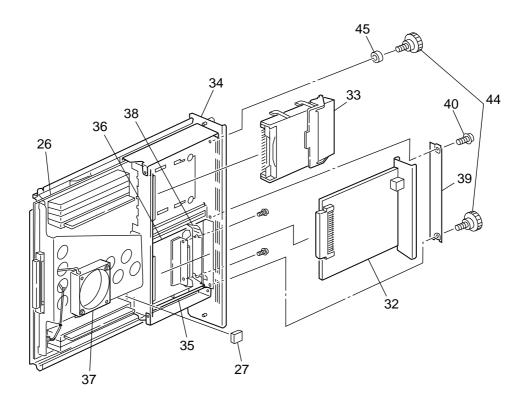
#### Main Assembly(3/3)

Board Assy.-CU(Maintenance) 34 [41848502] consists of a set of a bracket to support Motor Fan 37 (41410201), a sheet metal to secure PCB Assy-SWA 26 (41716819, 41716820), a gasket bonded to that sheet metal, and screws (attached to the assembly).

The number 26 (PCB Assy-SWA [41716819, 41716820]), which must be replaced together with the metal and its grouped parts in 34, is given a set of part Nos., i.e. the No. of the discrete PCB and the No. of the metal.

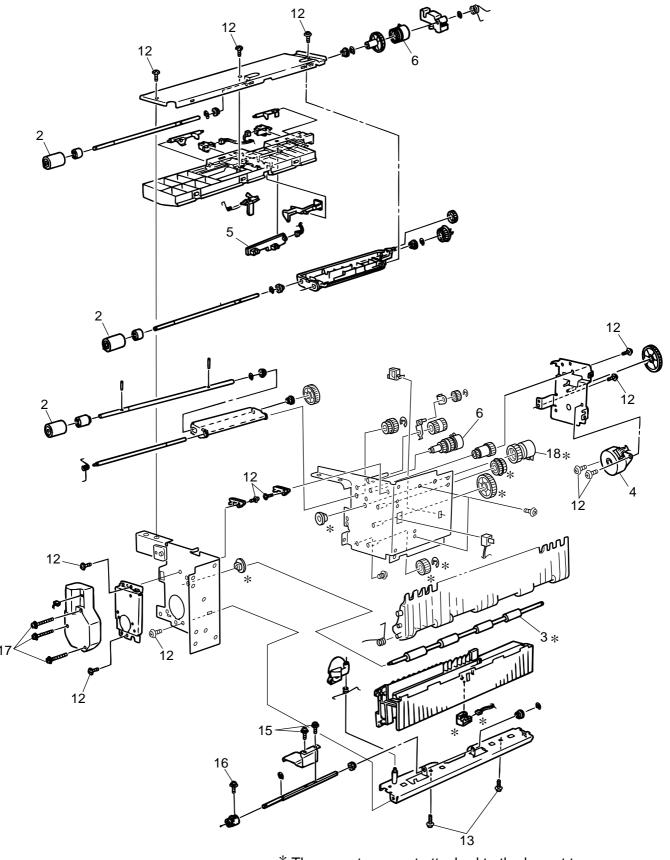
### High Capacity Tray Unit, 2nd/3rd Tray Unit(2/2)

$\ensuremath{^{*}}$  These parts are not attached to the lowest tray.
